Manhole Inspection Summary

Manhole # S37A__023MH

Location Address: **403 e centre st**

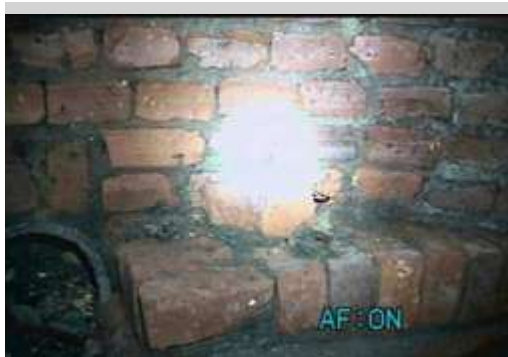
Defect 4

Condition: ☐ Sound ☒ **Cracked** ☐ Root Intrusion ☐ Deteriorated ☐ Leaks ☐ Debris

crack bench & bench debris

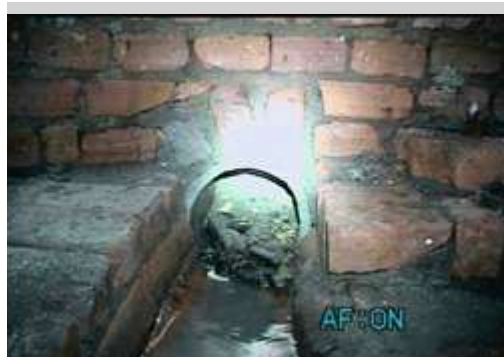
Defect 3

Condition: ☐ Sound ☐ Cracked ☐ Root Intrusion ☐ Deteriorated ☐ Leaks ☒ **Debris**

channel debris

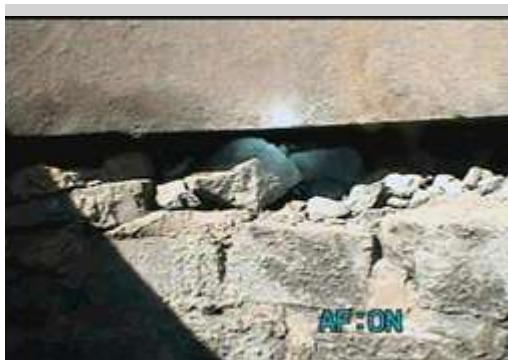
Defect 2

Condition: ☐ Sound ☐ Cracked ☐ Root Intrusion ☒ **Loose Brick** ☐ Deteriorated

loose bricks,frame adj

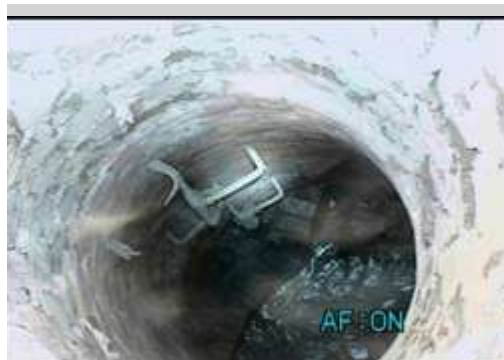
Defect 1

Count: **5** Missing: **2** ☒ **Corroded**

cor. steps

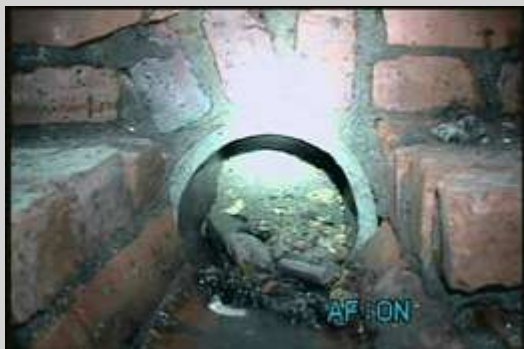
6 O'Clock Inflow

Deposits: ☐ None ☐ Mud ☐ Sludge ☒ **Debris** ☐ Grease

Silt Depth: 3 (in.) Deposits Extent: **Medium**
